HIGH VELOCITY IMPACT

Wensseler Polytechnic Institute
in partial fulfillment of the re-
quirements for the
Degree of Master of Civil Engineering

Summer Term
1948

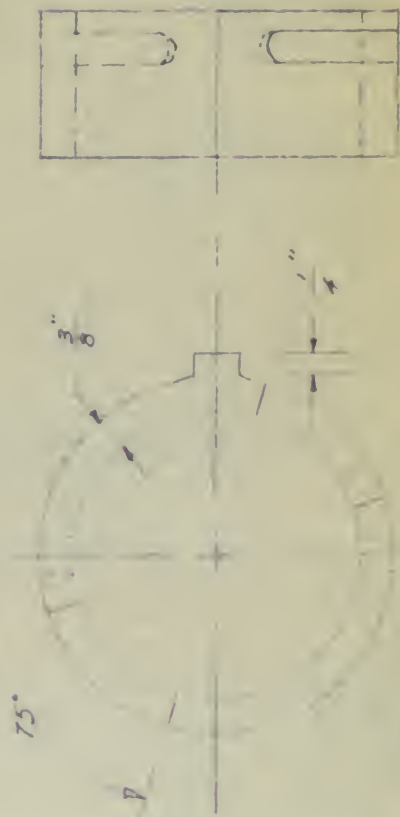
FIG. 6

HAMMER & PIN - FULL SCALE

RING - HALF SCALE

PROPOSED MODIFICATION
OF LOADING MACHINE

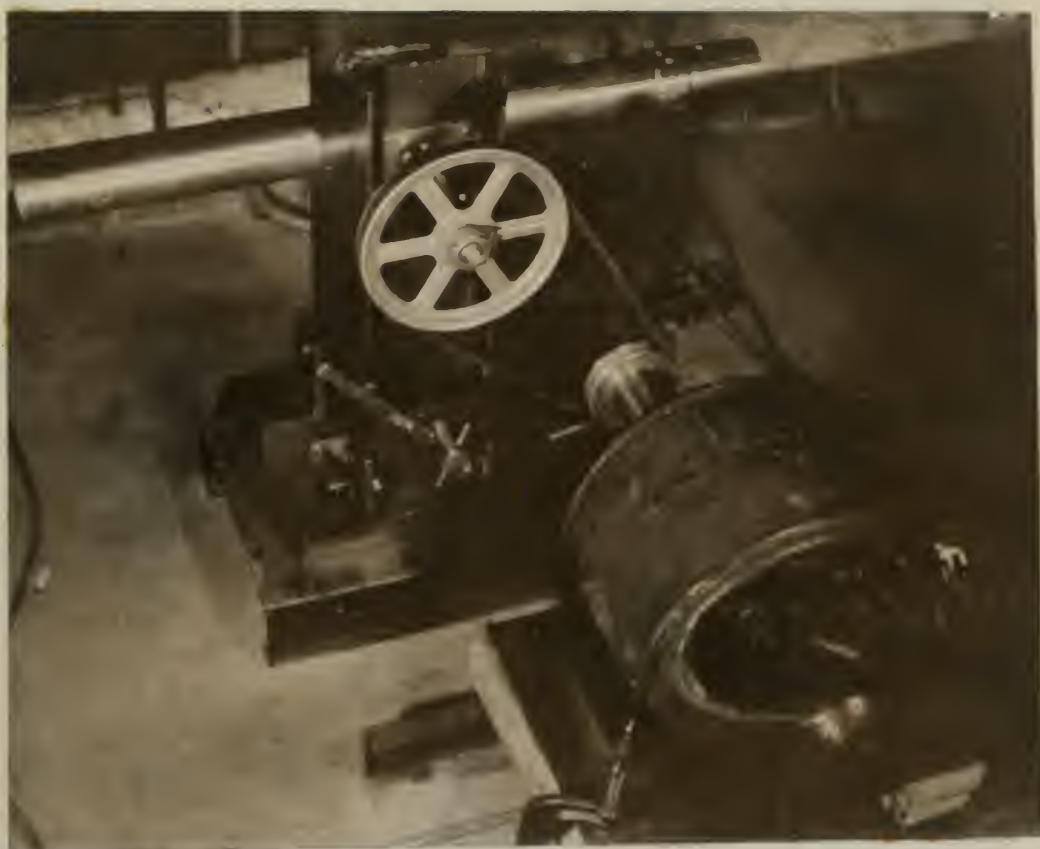
FACTO A
General view of Loading Machine

The apparatus shown in photographs A to D was devised as the best solution to the problem from the standpoint of simplicity in operation and construction. It consisted to a 3" O.D. $\times \frac{1}{2}$ " wall steel tube through

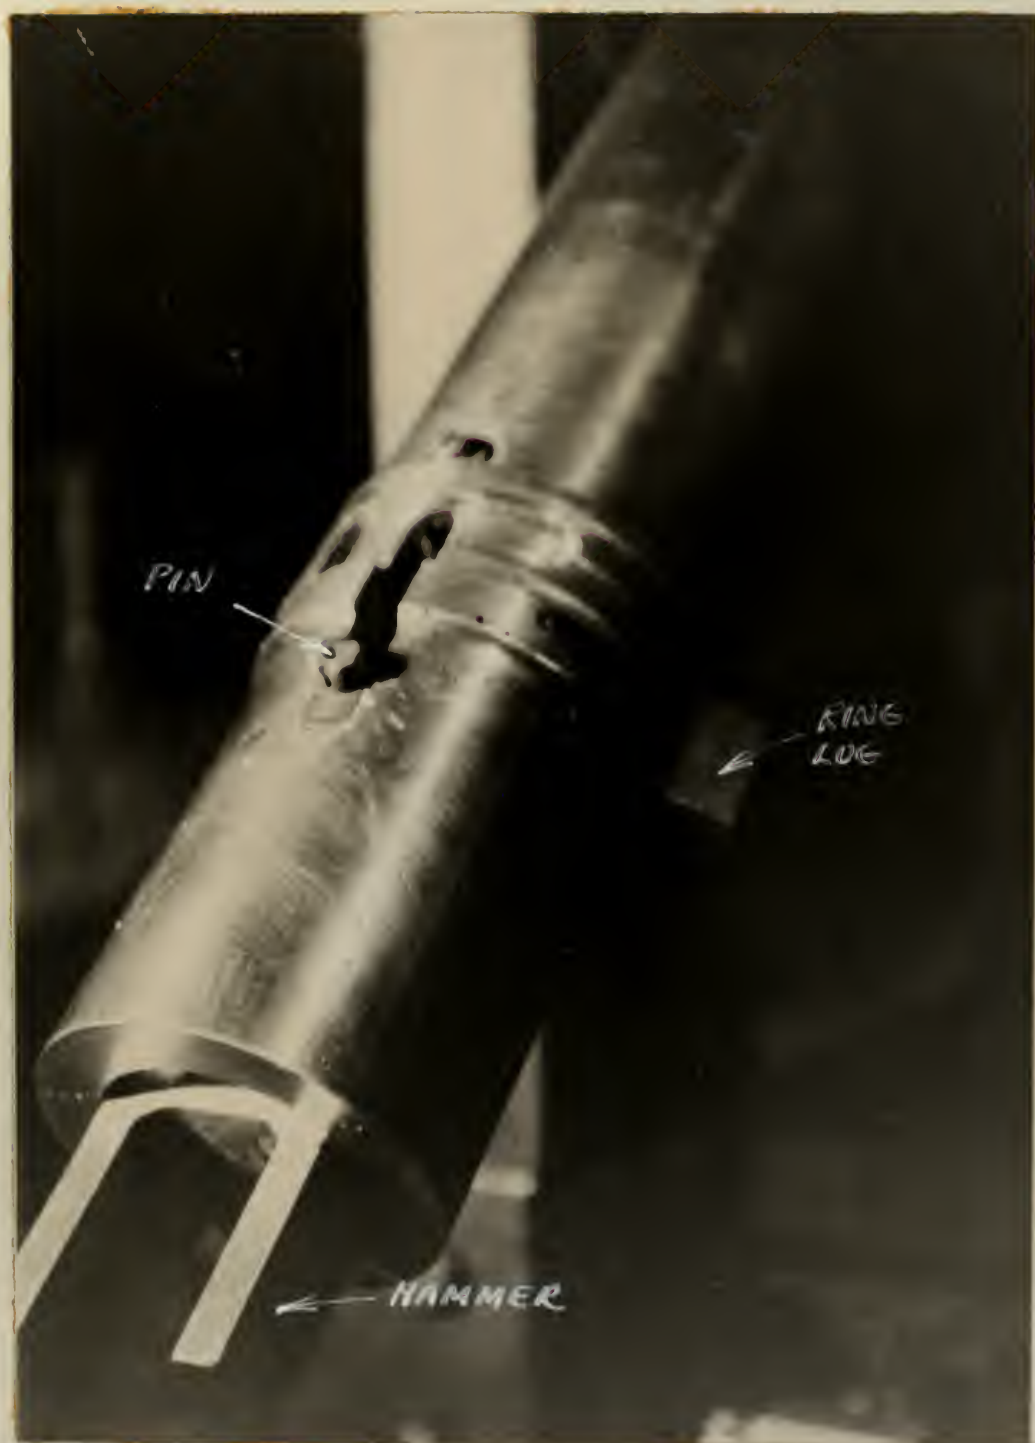
PHOTO 2
View of Hammer and Ring

which the striking hammer could slide. The mechanism for releasing the hammer consisted of a ring equipped with slots which engaged a pin mounted in the hammer as shown in photographs D and E. This ring was made with a projecting lug which engaged a tripping plunger as shown in photograph D. When the contact between the ring lug and the trip plunger was made, the rotating movement of the tube forced the ring to rotate about the tube and thus release the hammer. The hammer was to be propelled by centrifugal force along the axis of the tube until it was stopped by the pin bearing against the end of the slot in the tube. The forked end of the hammer was then in a position to clear the specimen and to engage the top, thus imparting the impact loading that was desired. The opposite end of the tube was provided with a means of balancing the entire rotating assembly. A movable weight was used for this purpose which was actuated by screw threads and provided with a lock screw. The tripping plunger was spring loaded and was actuated by a lever as shown in photograph (D).

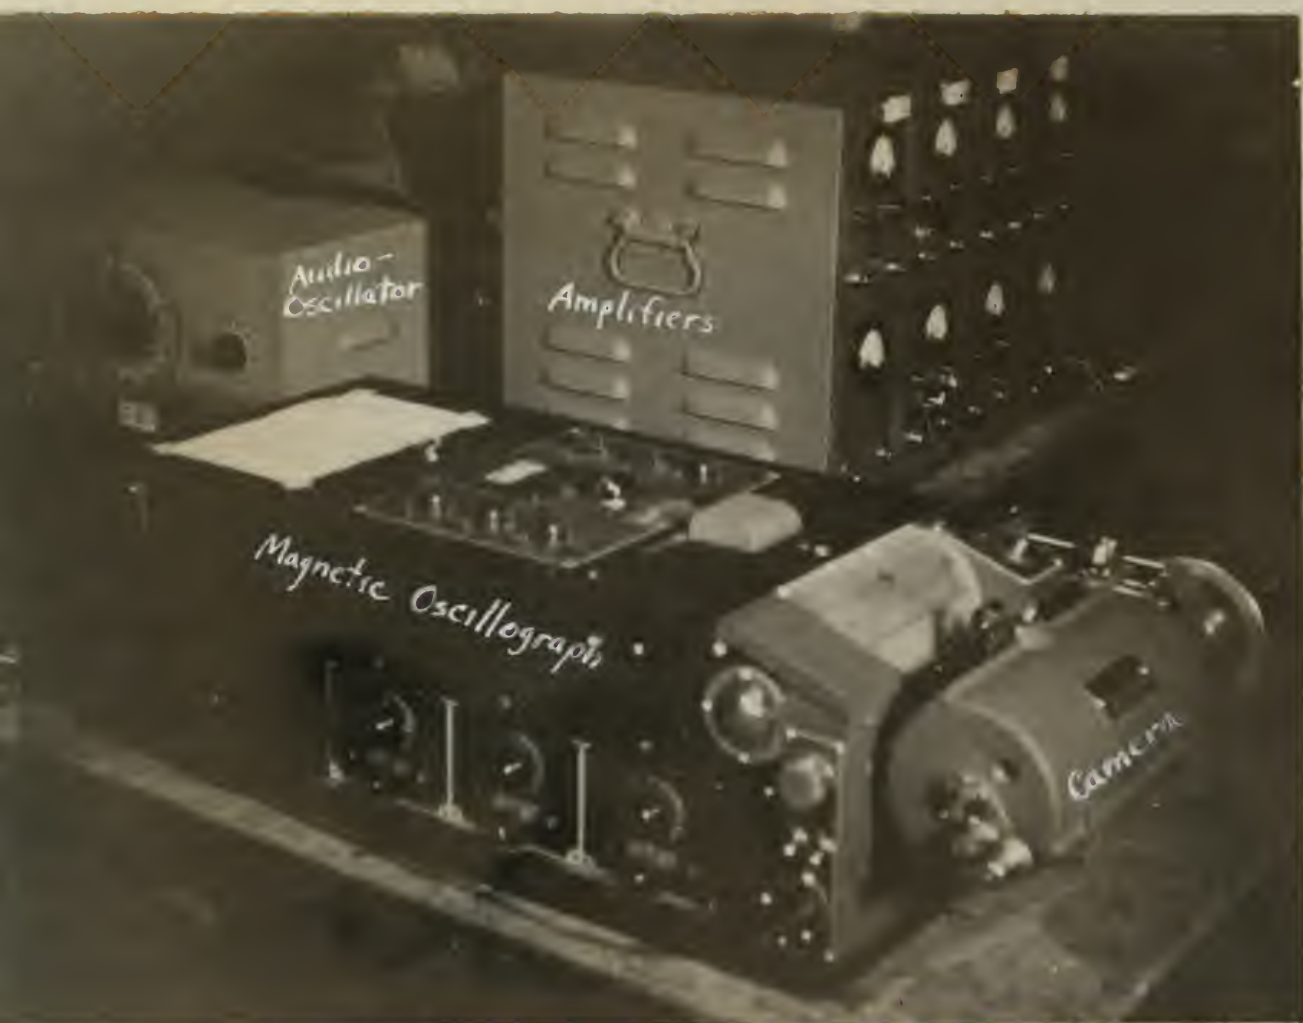
PHOTO B
View of Instruments

of a Wheatstone bridge. A four stage amplifier increased the signal, rectified it and fed it into a six channel General Electric Oscillograph type FM-1C-EE with high speed camera attached to record the galvanometer traces. The galvanometers were single element 52 type with a frequency response of about 5000 cycles. The magazine type film holder was used to take advantage of the highest possible film speed, 1270 KFu, which corresponded to 1270 fpm or 254 inches/sec. On such a time scale each inch corresponded to 2.94 milliseconds. A Hewlett-Packard Model 202 B Audio Amplifier was used to feed a timing wave into the galvanometer at 400 cycles. The set-up as finally used is shown in figure (7) and photograph (8).

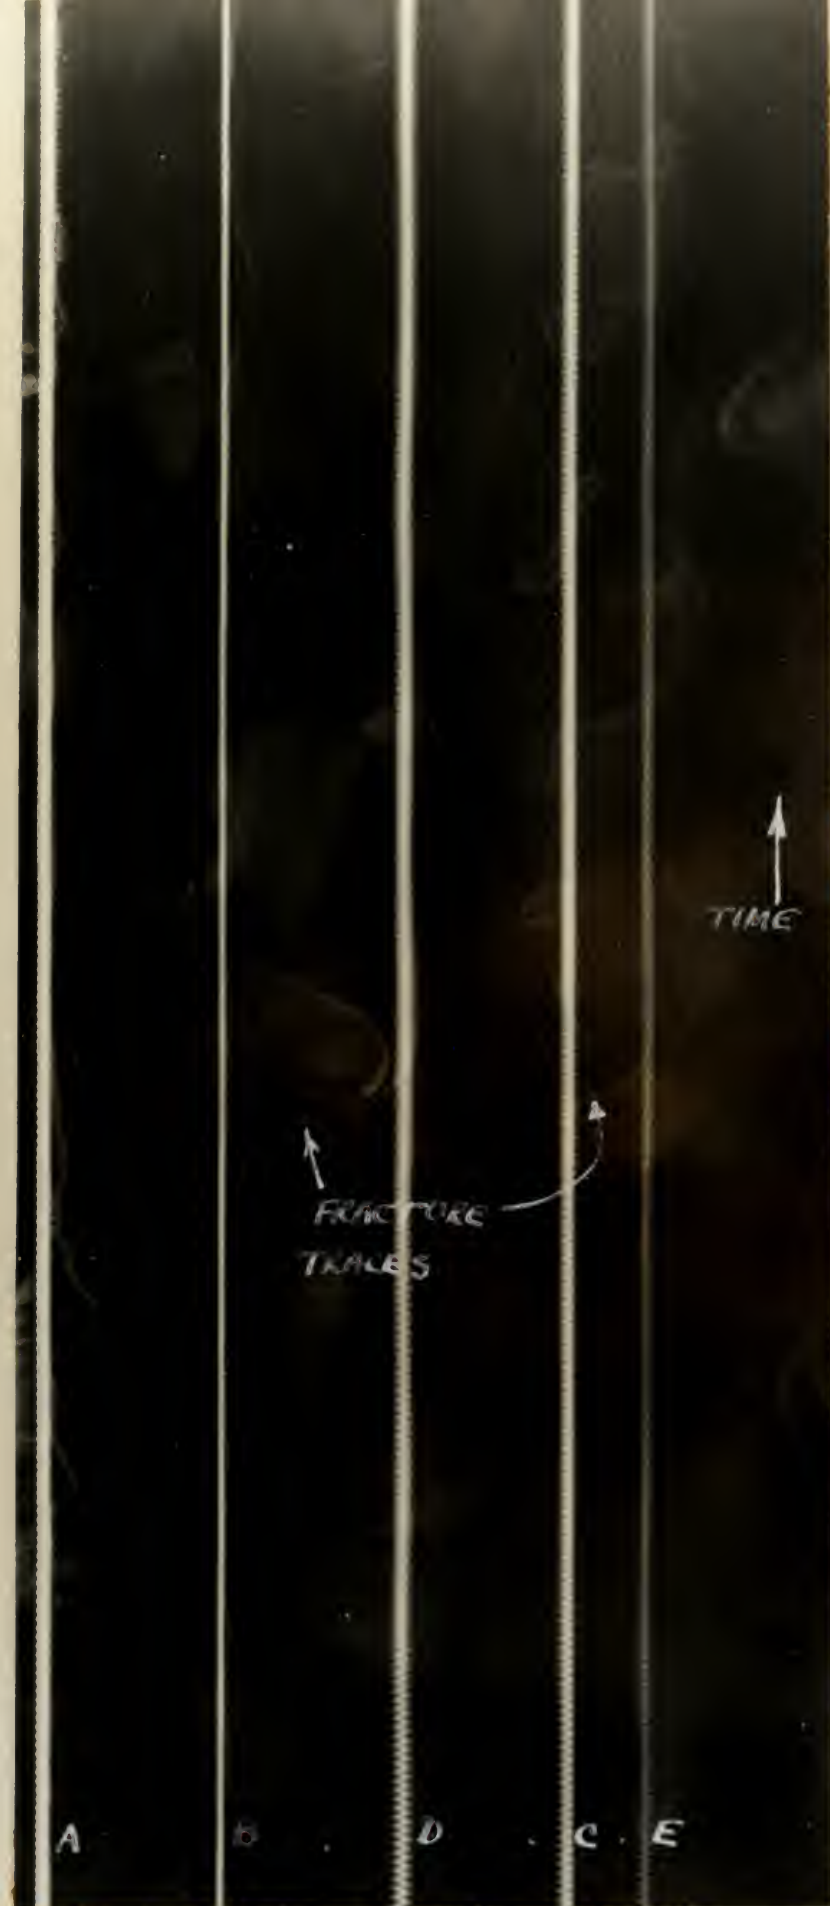
PHOTO J
Cecilligraphic Record

Photograph (J) is a print of the film record obtained of impact at 27 fps. Traces A, B and C are the zero positions of the forward and rear gages mounted on the specimen and the gage mounted on the holder, respectively. Traces D and E indicate the final position of A and B after fracture while the shutter was still open. A faint trace can be seen of the path of beam A from its original position to position D. The wave superimposed upon traces is 5000 cycle pick-up from the bridge-exciting oscillator. The timing wave was off the film to the right and would have appeared at the right margin of the film if it had been realized that the film did not extend to the entire width of the viewing screen. Fortunately the 5000 cycle corresponds to .0002 sec. of elapsed time. The distance from trace A to D represents 895 micro-inches/inch of strain and that from B to E represents 1226 micro-inches/inch. The significance of these figures is problematical. They may represent open circuit values of

amplifier current. Or, if the bond between gage and specimen failed before the circuit was broken, they may represent residual strain in the gage after the impact load was applied. At any rate it can be seen that the gage was recording less than 200 micro-inches of strain a full .001 of a second after impact although at 57 fps the hammer is traveling 0.68 inches in that time, or more than the total elongation observed. It would seem that either the gage is giving a false reading or rupture is taking place at considerably below 57 fps. The latter is the more likely explanation. A third alternative is the possibility that galvanometer response is not rapid enough to accurately trace the signal. The inertia of the mirror, however small, is finite and with an extremely rapid signal it may tend to spread out the signal along the time scale.

Neither trace B nor C give a visible track due possibly to a faulty rheostat on the oscillograph which limited voltage that could be applied to the lamp source of light. It is not certain that trace C, the gage on the steel holder, would have given any noticeable reading under any condition.
